SCALE	FULL	MATERIAL	SEE NOTE 1	CRD	TOLERANCES
PIN		FINISH	SEE NOTE 2	DATE	AS SHOWN
TITLE	MP-38 RECEIVER			REV.	UNLESS 2 D
					NO.

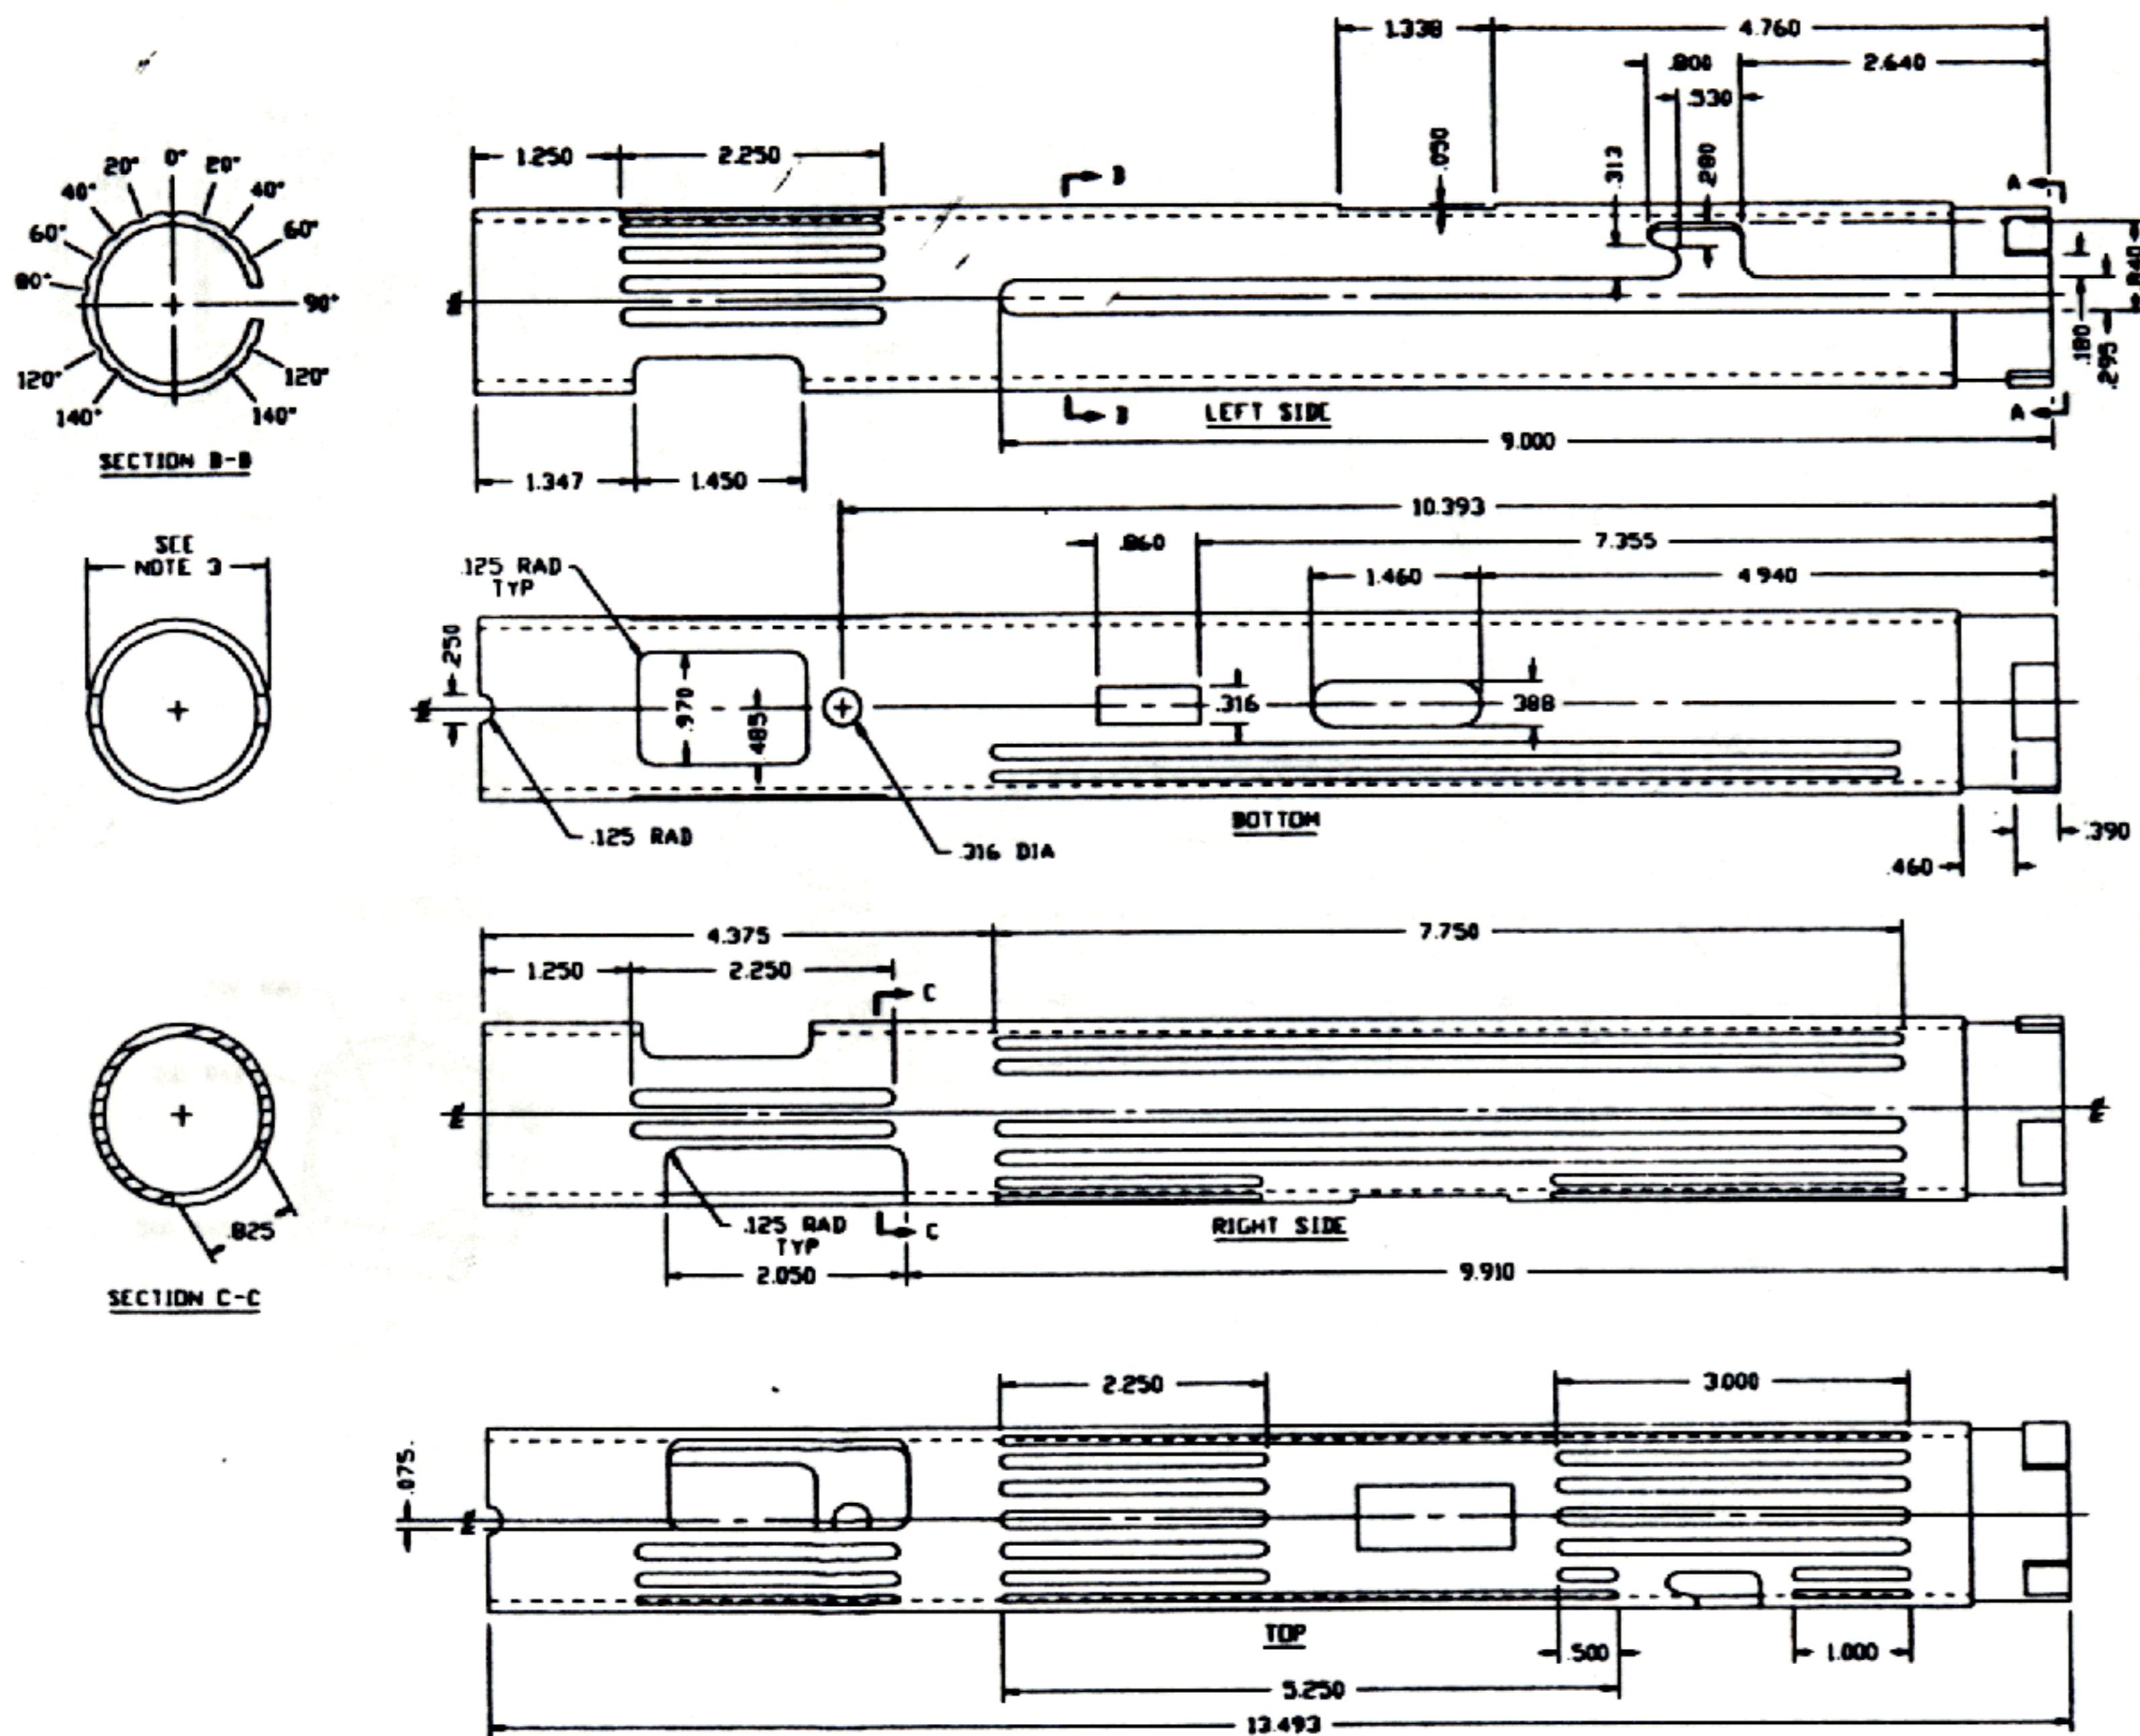
- NOTES:**
- MATERIAL - 1 5/8 O.D. X 1 3/8 I.D. D.O.M. STEEL TUBE
 - FINISH - BLUE
 - O.D. OF RECEIVER TUBE SHOULD MATCH I.D. OF MAGAZINE HOUSING AND REAR CUP OF TRIGGER FRAME
 - SLOT SIZES AND LOCATIONS ARE AS FOLLOWS
 MAGAZINE HOUSING AREA - A) 5 SLOTS 2.250 LONG ON LEFT SIDE OF RECEIVER AT 20°, 40°, 60°, 80° AND 100°
 B) 2 SLOTS 2.250 LONG ON RIGHT SIDE OF RECEIVER AT 80° AND 100°
 MAIN BODY AREA - C) 4 SLOTS 7.750 LONG RIGHT SIDE OF RECEIVER AT 60°, 80°, 120° AND 140°
 D) 5 SLOTS 2.250 LONG TOP SIDE OF RECEIVER AT 40°, 20°, 0°, 20° AND 40°
 E) 1 SLOT 5.250 LONG TOP SIDE OF RECEIVER AT 60°
 F) 4 SLOTS 3.000 LONG TOP SIDE OF RECEIVER AT 40°, 20°, 0° AND 20°
 G) 2 SLOTS 1.000 LONG TOP OF RECEIVER AT 40° AND 60°
 H) 1 SLOT .500 LONG TOP OF RECEIVER AT 40°
 - S SLOTS ARE FORMED WITH A CUTTER .200 WIDE FULL RADIUS X .030 DEEP

NOTE:
 HOLE IN MAGAZINE HOUSING IS THE FACTOR WHEN ASSEMBLED CROSS HOLE CHECKS ABOUT .215 THIS IS THE LAST HOLE TO BRILL AND AT ASSEMBLY.
